Forensic Building Science, Inc.

Insured: Memorial Inn & Suites
Property: 9535 Katy Fwy
Houston, TX 77024
Home: 123 Main St.
Saint Paul, MN 55105-3529

Type of Loss: Hurricane

FIELD REPORT FOR INITIAL STORM DAMAGE INVESTIGATION

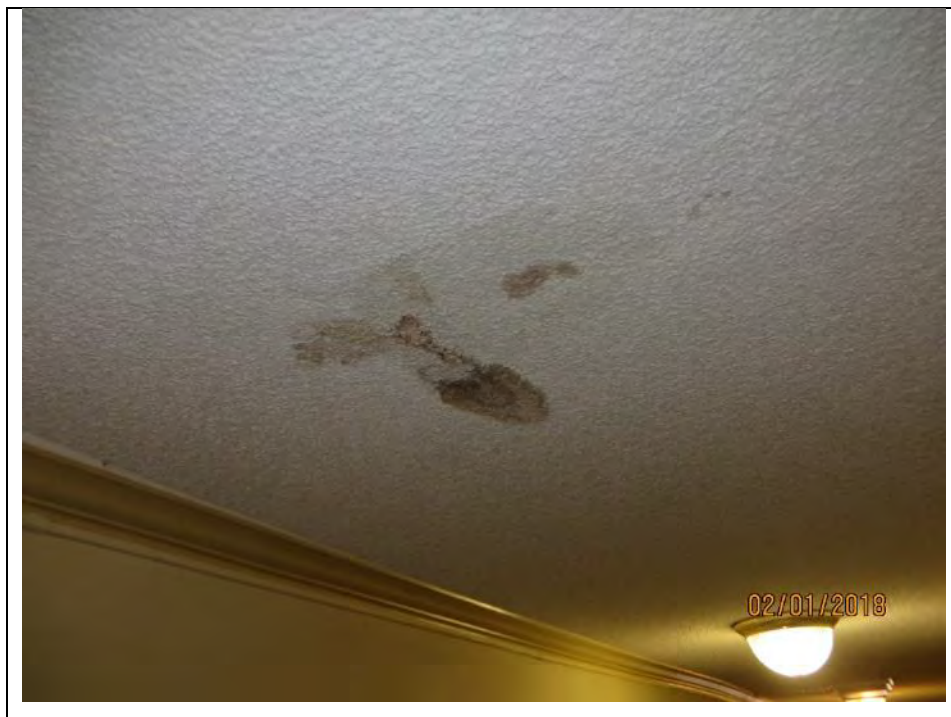
Figure 108. Typical water damage after storm (KJS)

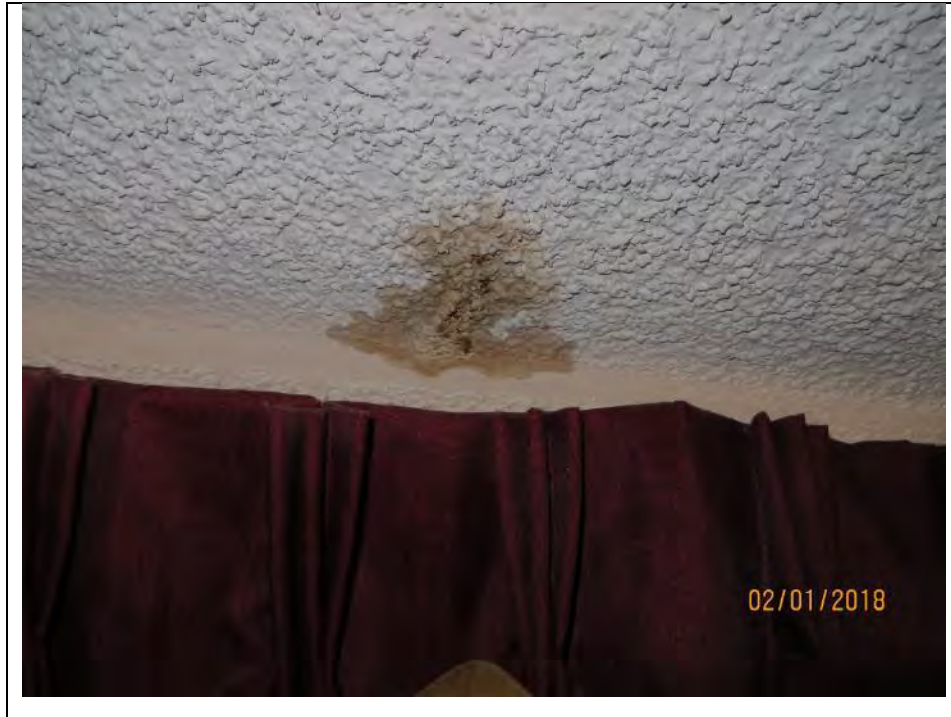
Figure 111. Typical water damage after storm (KJS)

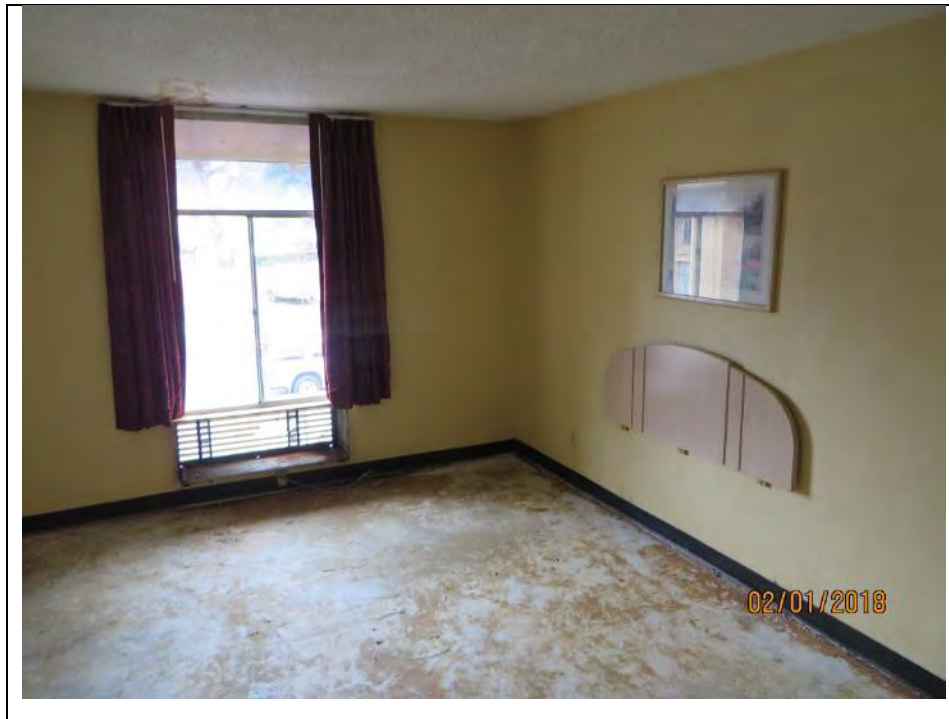
Figure 123. Typical water damage after storm (KJS)

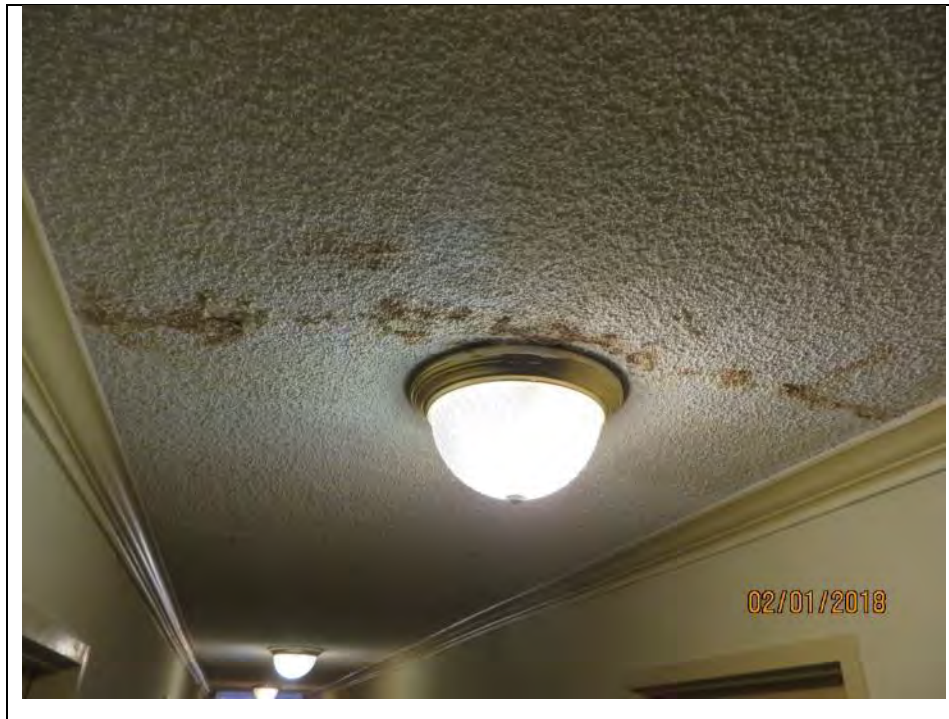
Figure 127. Typical water damage after storm (KJS)

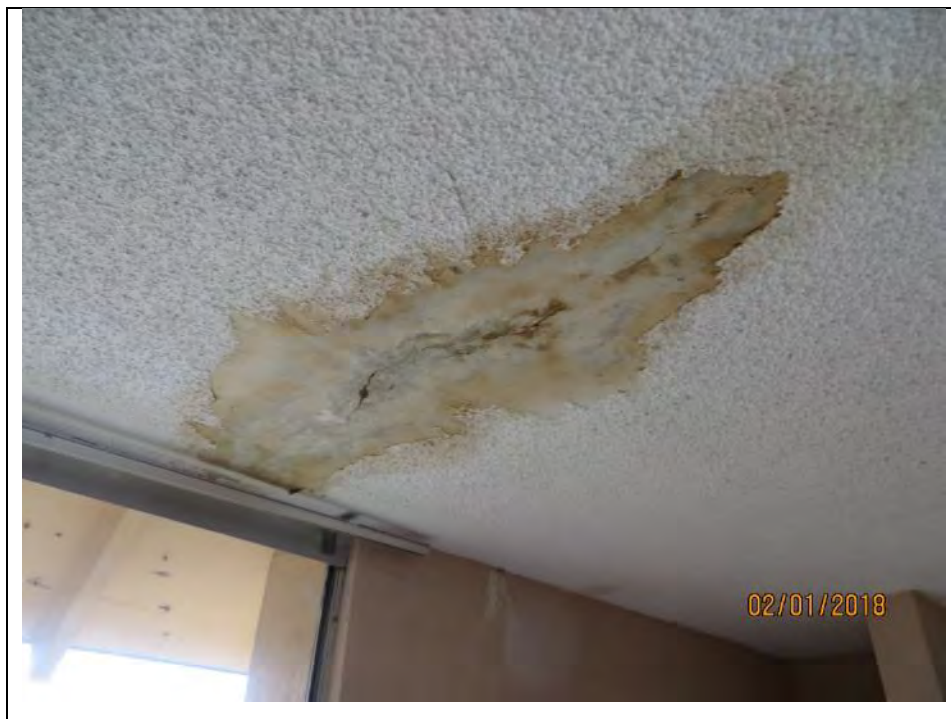
Figure 130. Typical water damage after storm (KJS)

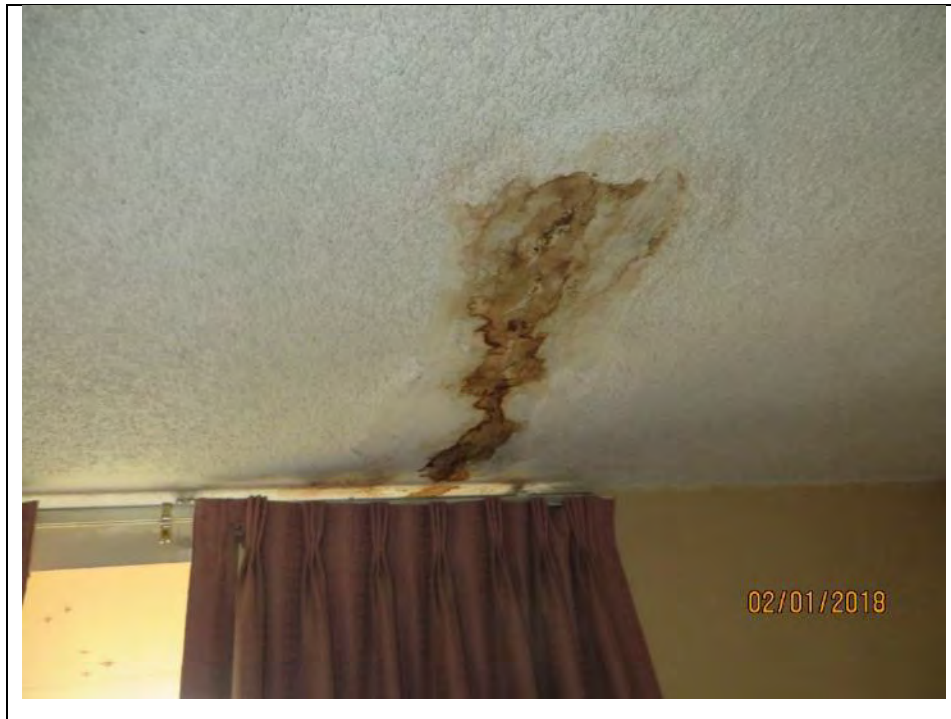
Figure 137. Typical water damage after storm (KJS)

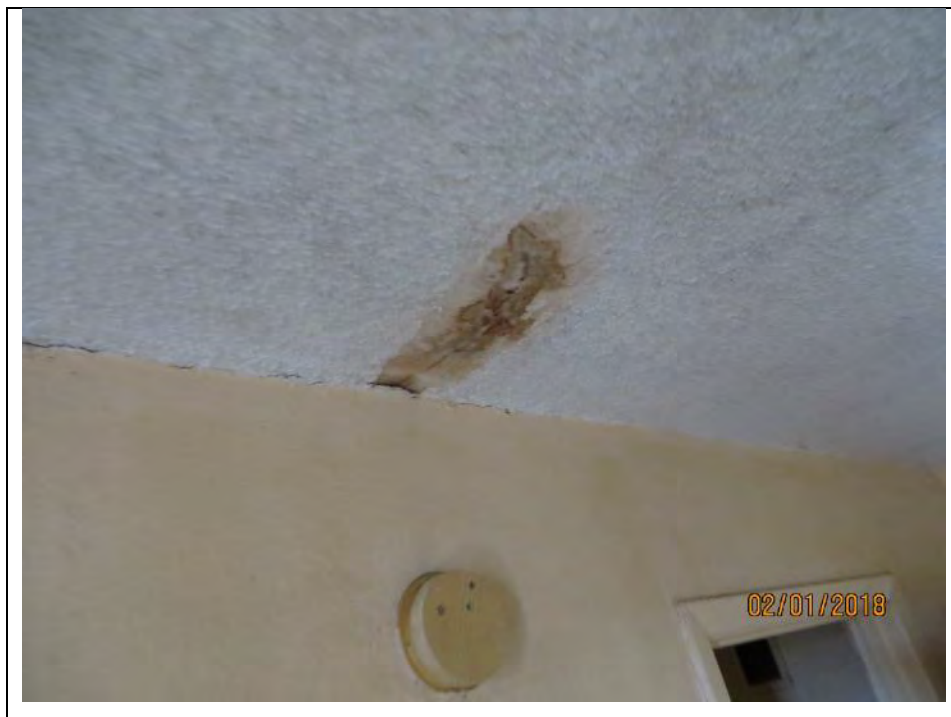
Figure 138. Typical water damage after storm (KJS)

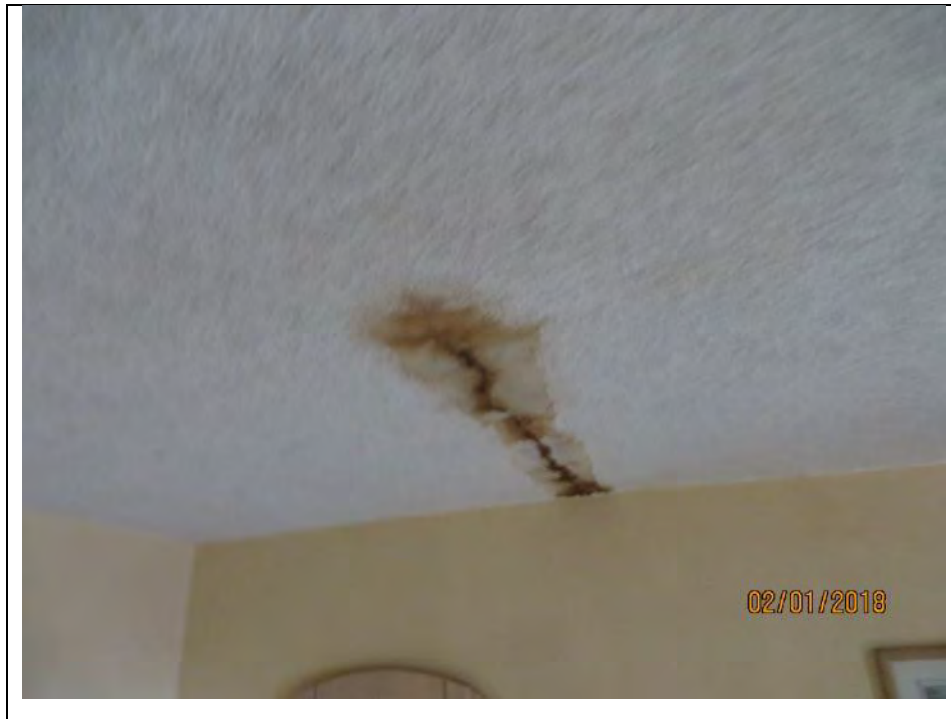
Figure 139. Typical water damage after storm (KJS)

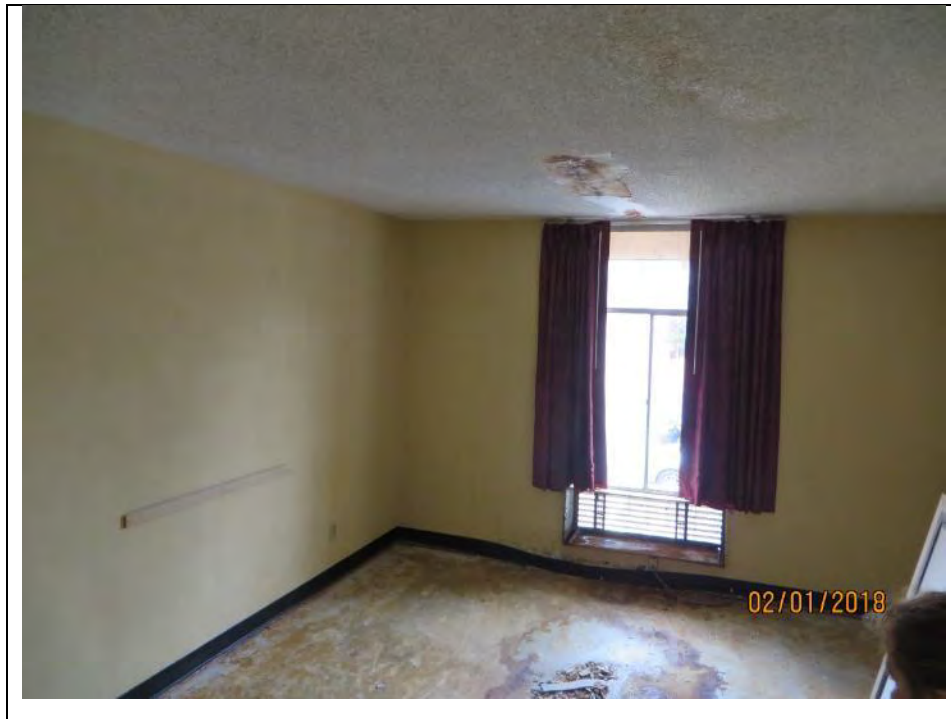
Figure 141. Typical water damage after storm (KJS)

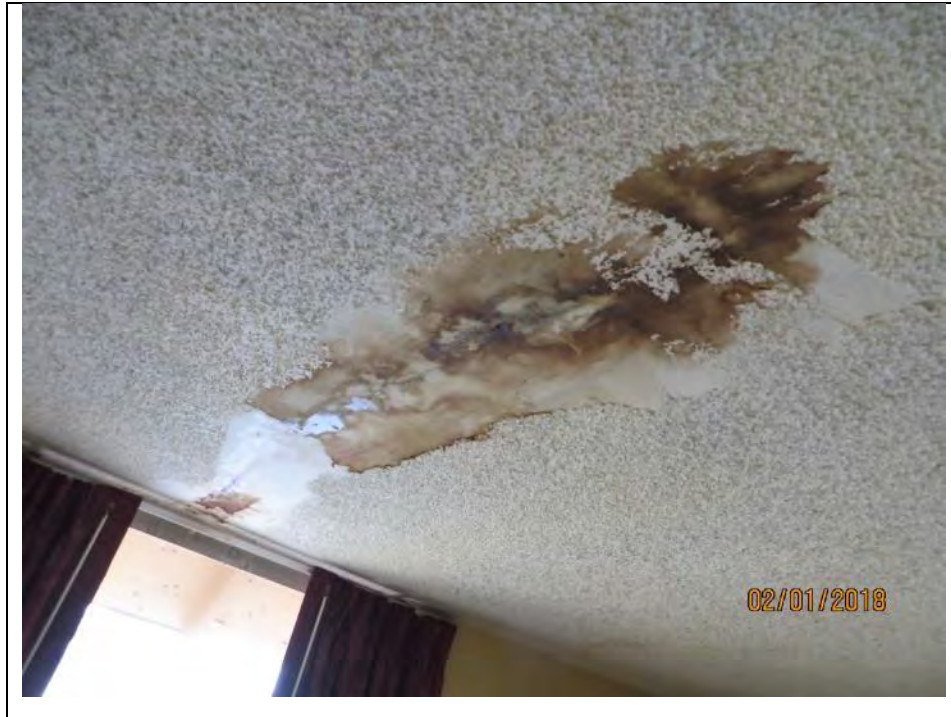
Figure 143. Typical water damage after storm (KJS)

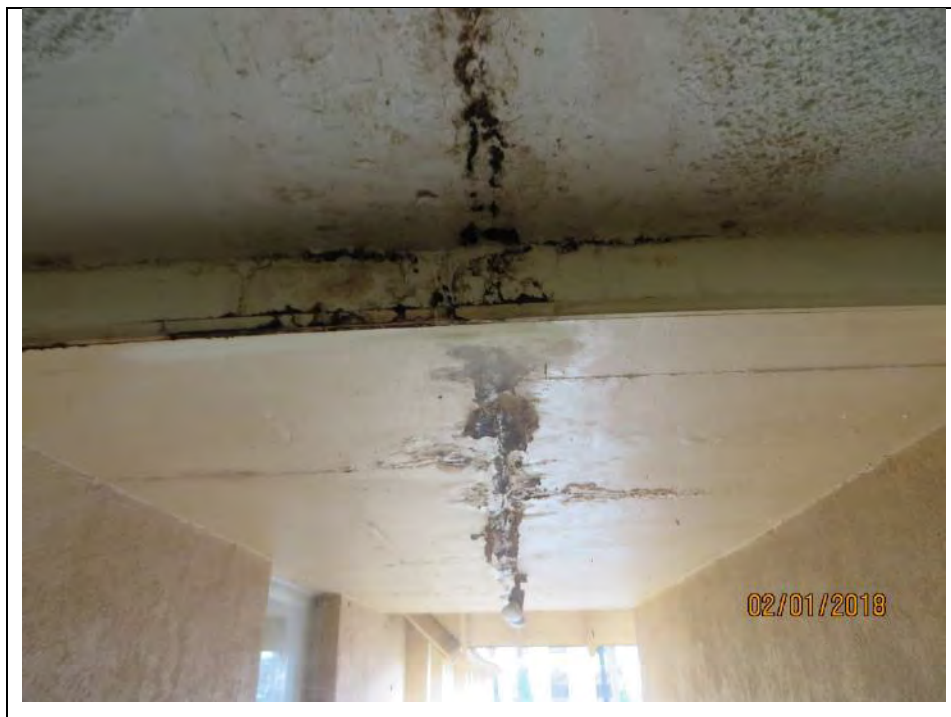
Figure 148. Typical water damage after storm (KJS)

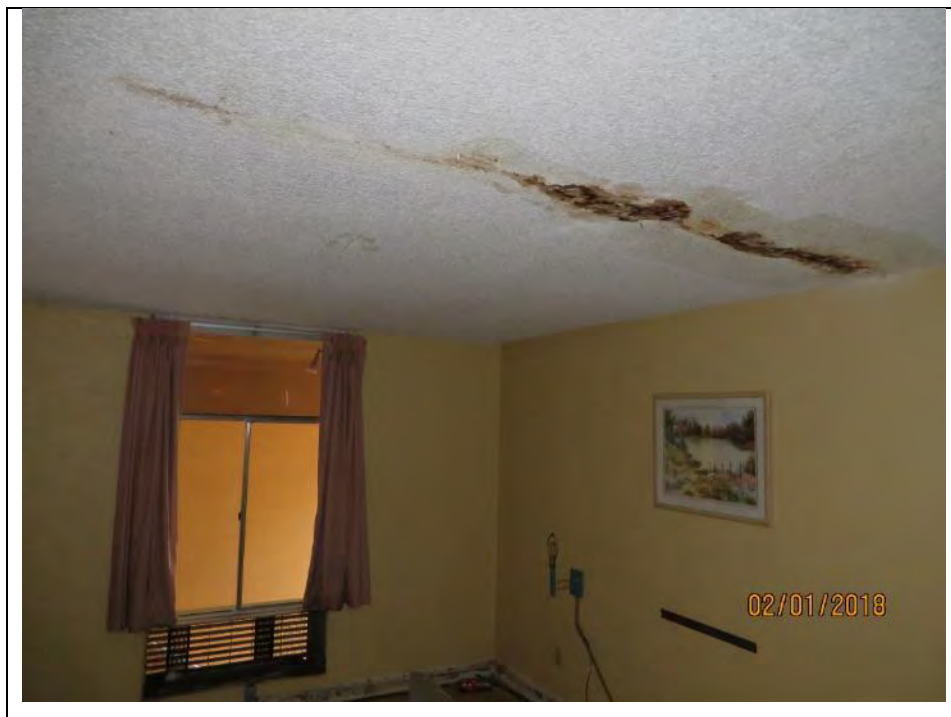
Figure 154. Typical water damage after storm (KJS)

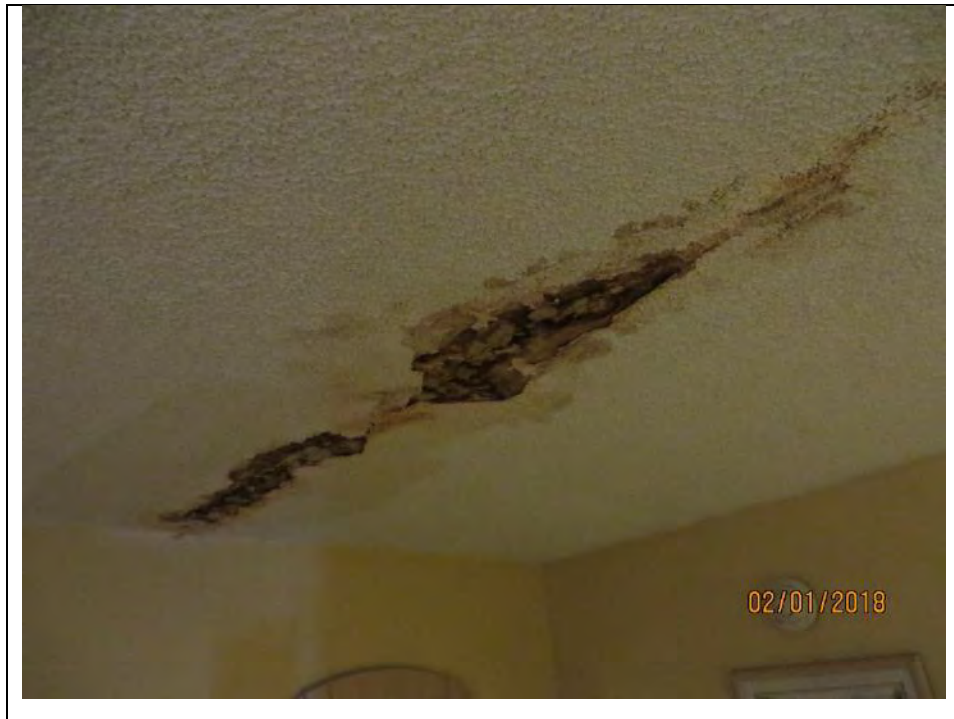
Figure 155. Typical water damage after storm (KJS)

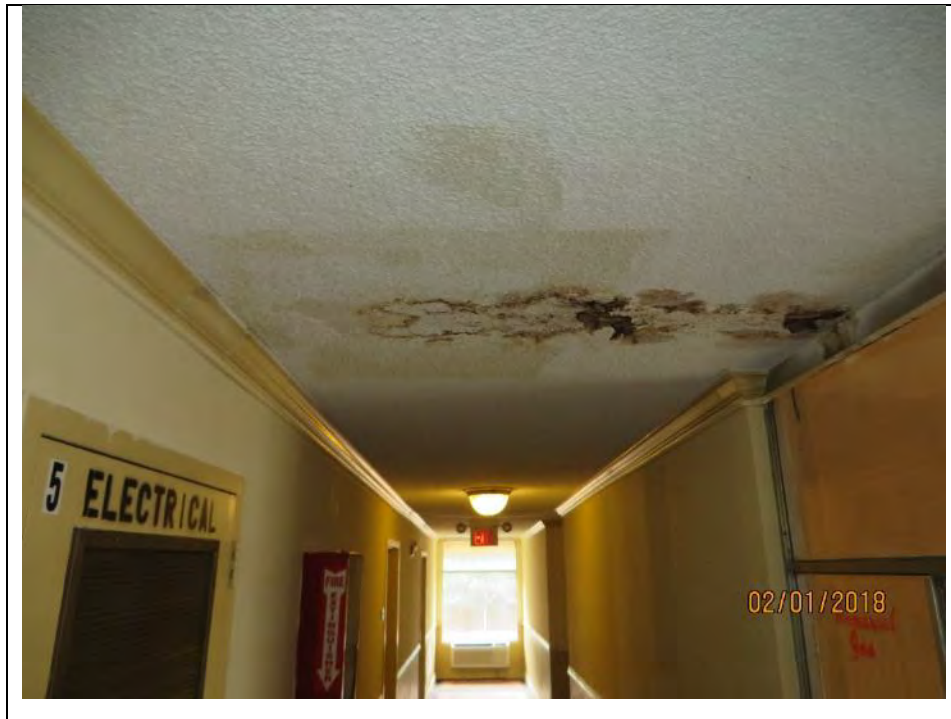
Figure 175. Typical water damage after storm (KJS)

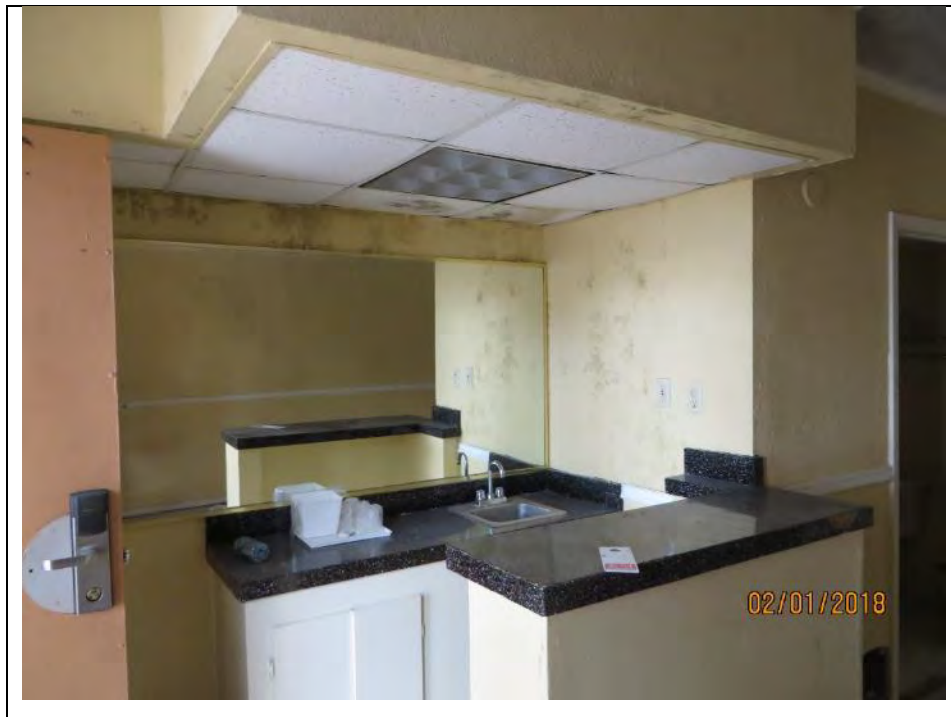
Figure 246. Typical water damage after storm (KJS)

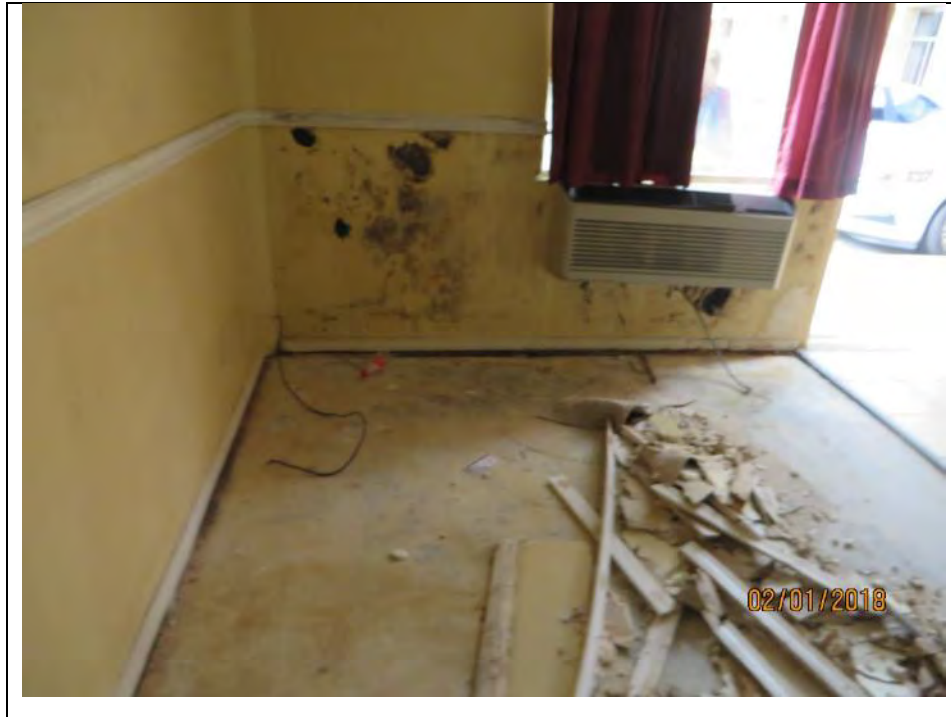
Figure 251. Typical water damage after storm (KJS)

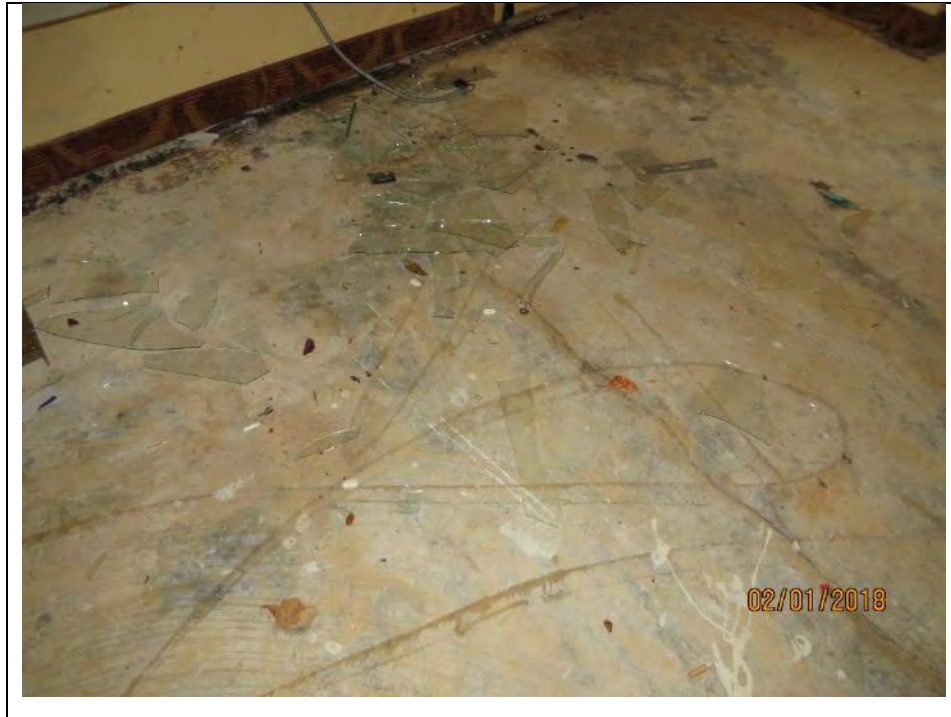
Figure 257. Typical water damage after storm (KJS)
